Is electric fencing an efficient and animal-friendly tool to prevent stone martens from entering buildings?

Claudia Kistler · Daniel Hegglin · Kuno von Wattenwyl · Fabio Bontadina

European Journal of Wildlife Research

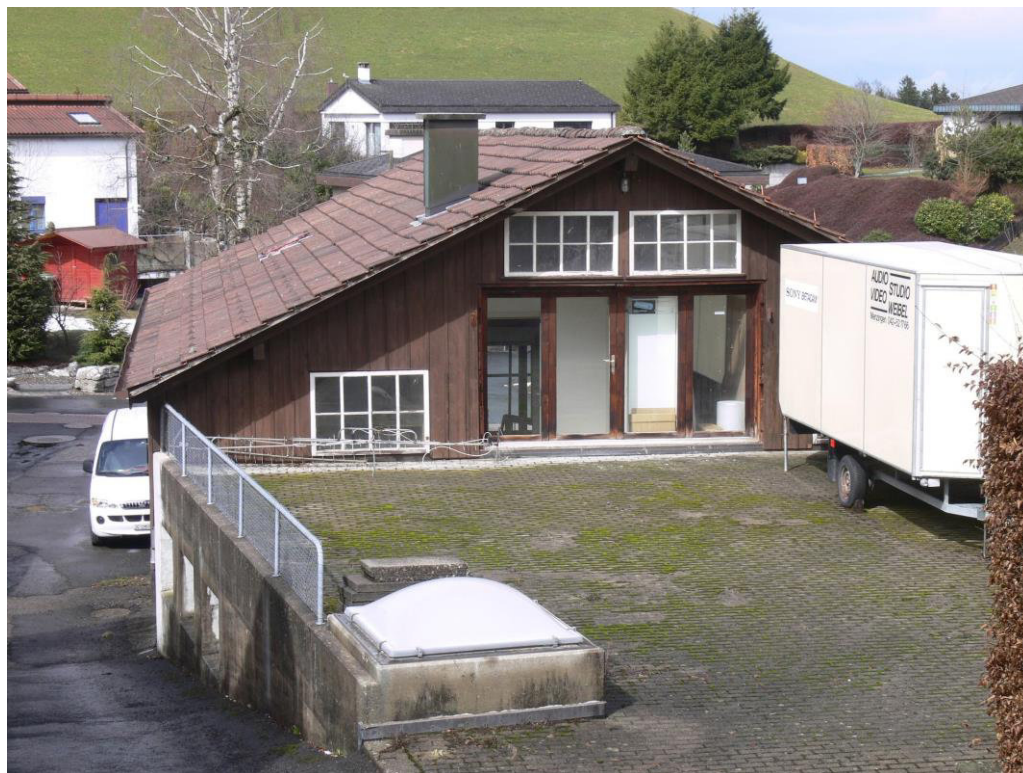
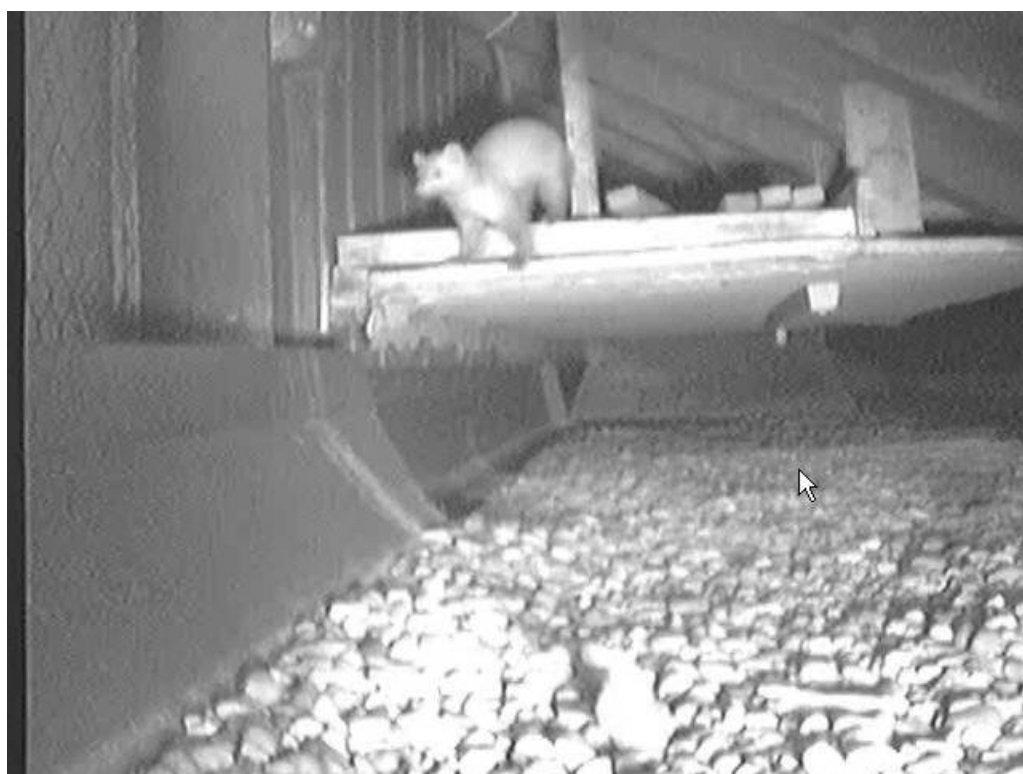
Online Resource 1. The Industrial building (above), and the marten at the opening that later was protected by the wire mesh (below) (DOCX 715 kb)

The study site was an industrial building built in the 1950s (Online Resource 1), situated in Menzingen, a mid-sized village in the canton of Zug, Switzerland. The martens had used the attic of this building for many years as a resting site and had caused serious damage to roof insulation. Video recordings (see below) were made from 12 June to 27 July 2006, for a total of 26 nights. Thereafter, the presence of martens was monitored by checking for faeces and for bait take (dried apricots and dog biscuits) from 27 July to 06 November 2006 (103 days).
